# MOLD INSPECTION REPORT

## METRO ONE HOME INSPECTION<sup>TM</sup>

100 Metro One Home Inspection  
Kansas City, MO 64063

# MOLD INSPECTION SUMMARY

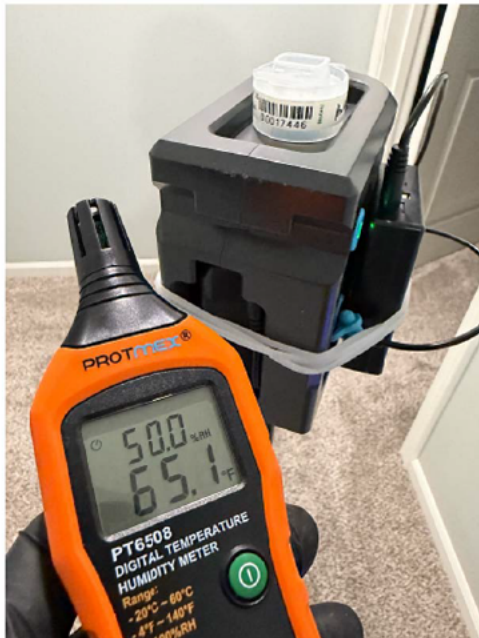
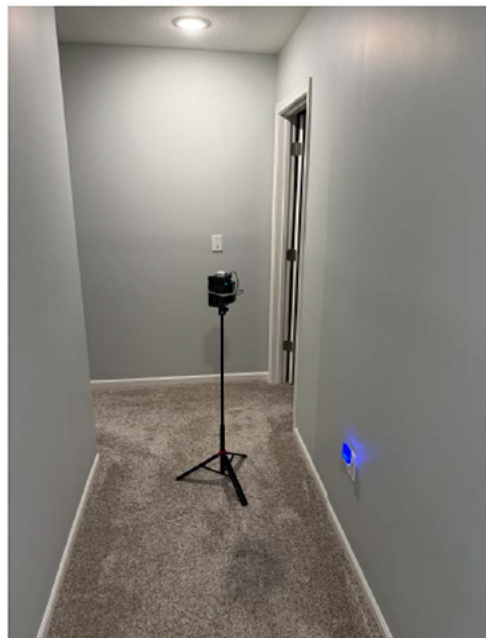
## SAMPLE #2

**LOCATION:** HALLWAY

The types and concentrations of mold found in this sample are highly elevated compared to the levels found in the outdoor control sample.

These results are a strong indication that there is a possibility of mold or moisture problems in the home.

Sporecyte strongly recommends hiring a qualified mold professional to do a detailed assessment of the property for mold and moisture issues.

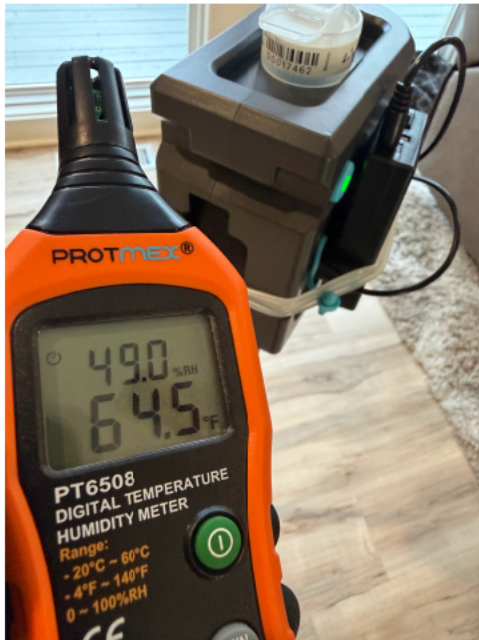
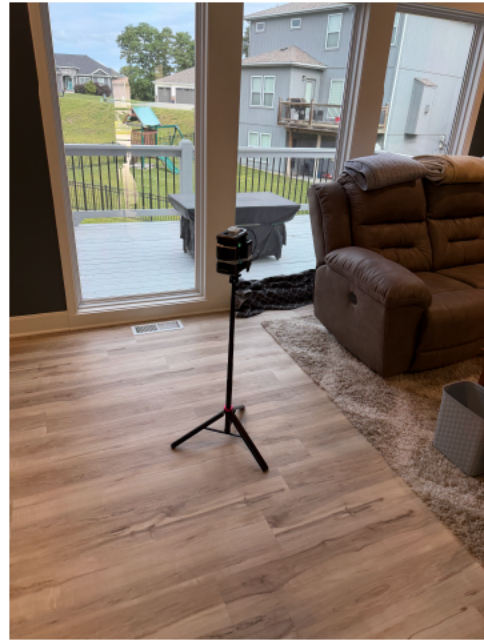
**LOCATION:** LIVING ROOM

The types and concentrations of mold found in this sample were found to be similar to what was collected in the outdoor control sample.

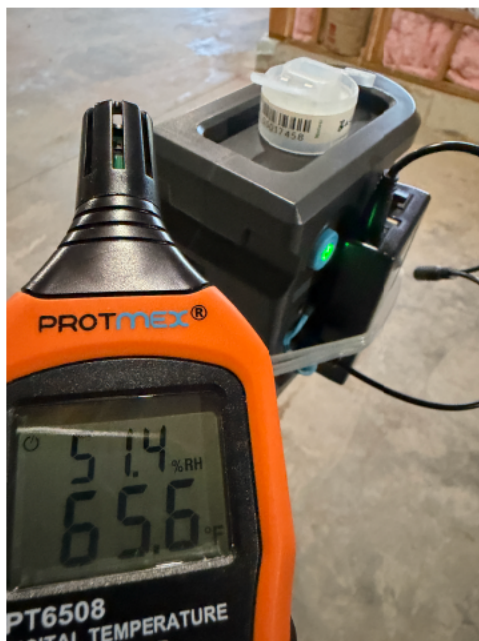
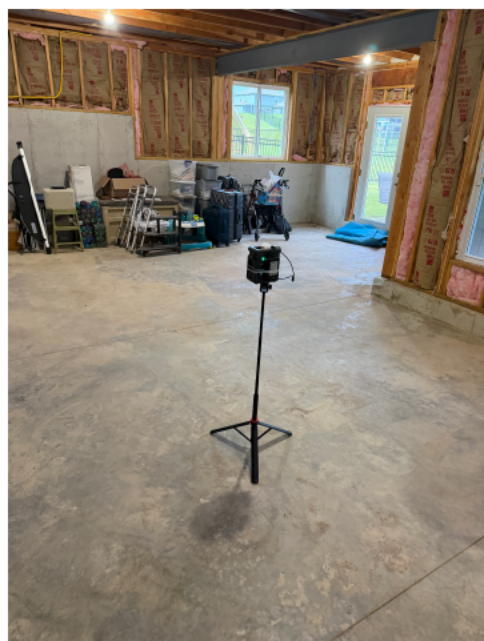
### SAMPLE #4

**LOCATION:** BASEMENT

The types and concentrations of mold found in this sample are highly elevated compared to the levels found in the outdoor control sample.

These results are a strong indication that there is a possibility of mold or moisture problems in the home.

Sporecyte strongly recommends hiring a qualified mold professional to do a detailed assessment of the property for mold and moisture issues.

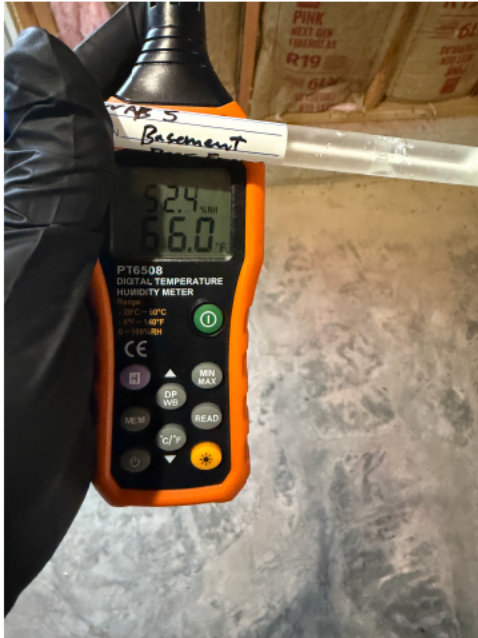
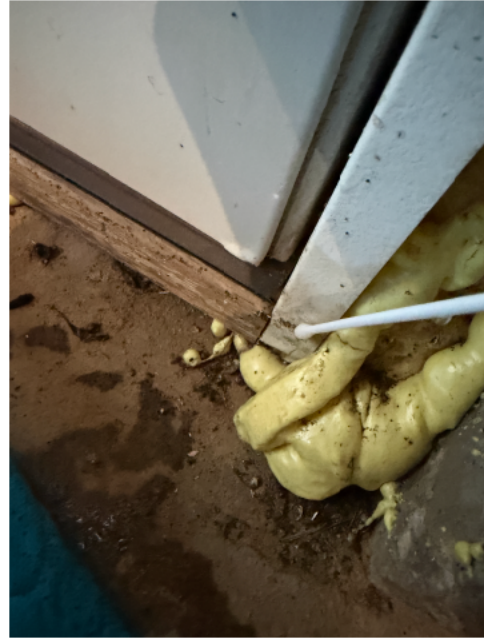
### SAMPLE #5

**LOCATION:** BASEMENT DOOR FRAME

This sample has determined that physical mold growth exists on the surface which was sampled.

We recommend hiring a qualified mold professional to perform a detailed assesment of the area to determine the scope of the mold and moisture issues.

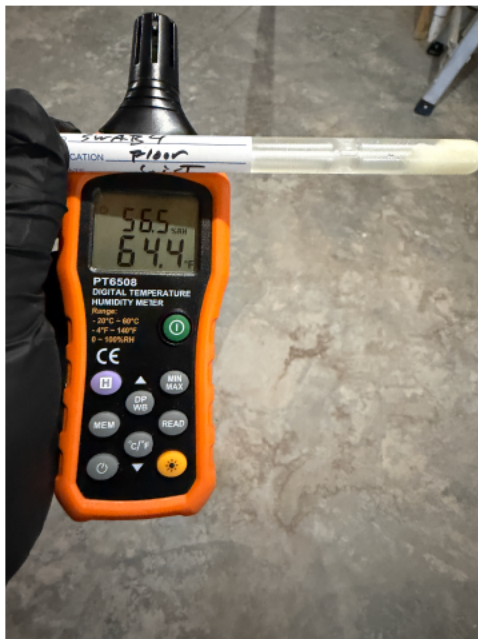
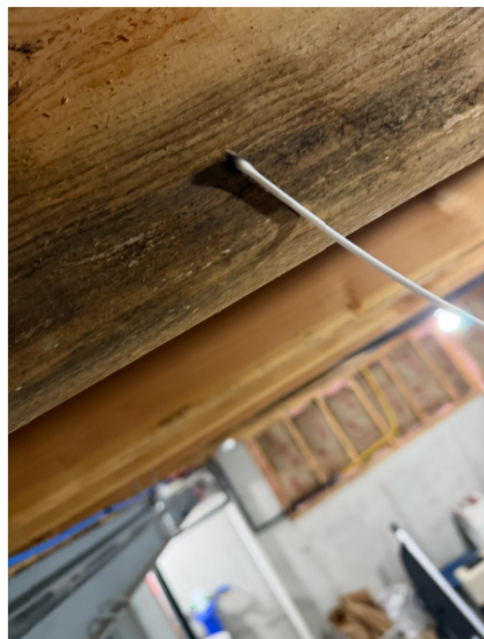
### SAMPLE #6

**LOCATION:** FLOOR JOIST

This sample has determined that physical mold growth exists on the surface which was sampled.

We recommend hiring a qualified mold professional to perform a detailed assesment of the area to determine the scope of the mold and moisture issues.

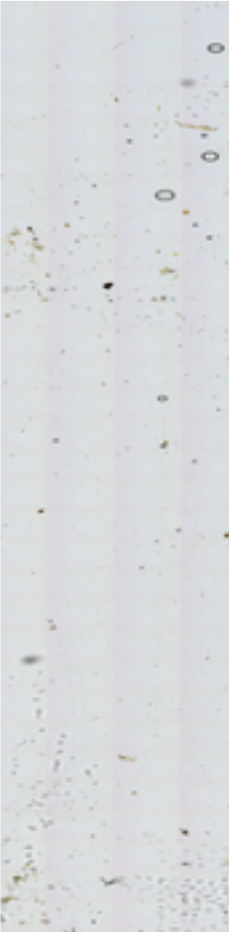
| Fungal Identification | Fungal Growth | Background Spores |
| Aspergillus / Penicillium | — | Present |
| Cladosporium | Light | — |
| Hypha | — | Present |
